ERDC/GSL SR-03-2

Evaluation of Runway Preservation System

ERDC/GSL SR-03-2
March 2003

Final report

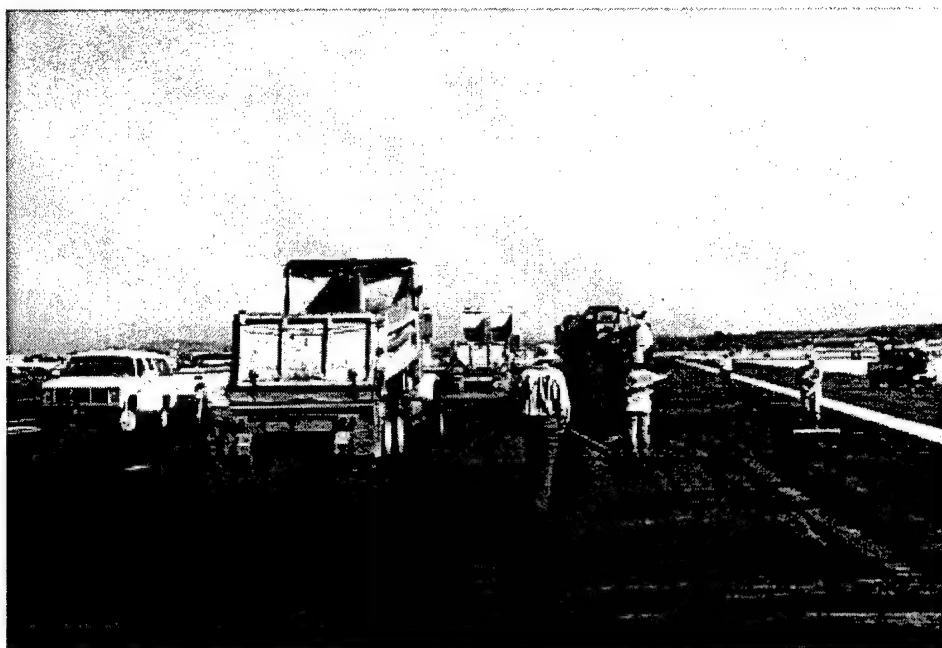
Photo 4. Applying aggregate to the runway. Note the squeegeeing of excess material on the edge of the grooved pavement

The application of the diluted RPS material involved the spray application of the emulsion at a rate of 0.9 L/sq m (0.2 gal/sq yd). Hand-held squeegees were used to assist in applying the sealer in areas that could not be reached with the spray bar (Photo 3). The application rate had to be monitored or excess RPS material would get into the pavement grooves and flow out through the lower edge of the runway (Photo 4). The concentrated RPS had been delivered to the Portland, OR, area in a rail car. A sand-sized aggregate was immediately applied to the surface after the application of the RPS. The aggregate applied was a 30-60 material, indicating that at least 95 percent of the aggregate passed the 600- μ m (No. 30) sieve and at least 95 percent of the aggregate was retained on the 250- μ m (No. 60) sieve. The rate of application ranged from 0.34 to 0.45 kg/sq m (0.75 to 1 lb/sq yd). The aggregate was applied using large dump trucks with spreading units attached to the back (Photo 4).

The contractor was able to get a uniform application of the RPS emulsion and the cover aggregate onto the pavement. Because it was a spray application, the grooves in the pavement surface were not completely filled. Along with the aggregate added, the surface should remain sufficiently skid resistant. Some excess emulsion flowed through the grooves to the edge of the runway because of its slope. This excess emulsion was worked and spread on the shoulder by hand squeegees (Photo 4).

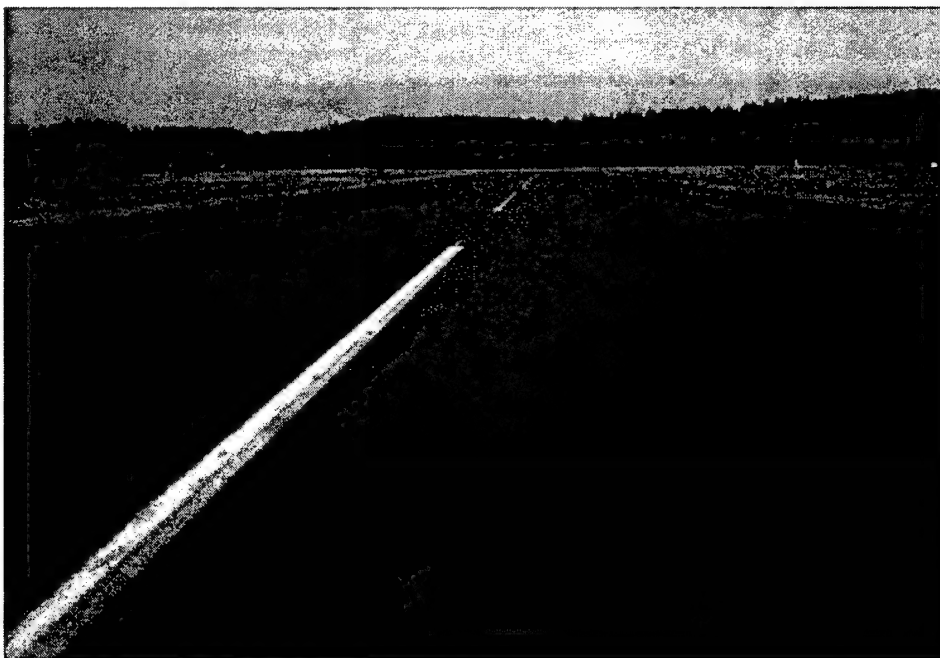
Photo 6. Overall view of Mulino General Aviation Airport

Mulino General Aviation Airport. The runway of the Mulino General Aviation Airport, near Portland, OR, was visually evaluated on 23 August 2000 (Photo 6). The airport runway had been paved 9 years earlier and then coated with GSB-88 2 years after that. According to the manufacturer, the HMA pavement had been constructed with a very absorptive aggregate. Prior to application of the coating, the pavement surface had become very dry and began to experience some raveling. The pavement was coated with 0.77 L/sq m (0.17 gal/sq yd) of GSB-88. The sealer is designed to penetrate sufficiently to prevent traffic from wearing it off the surface (Photo 7). Aggregate is not normally required; however, for smooth-surface pavements, it can be applied when required to absorb the excess GSB-88.
